WONDER QUEST with April Holladay, A Weekly Column \* February 7, 2001\* Albuquerque

## Crackling power lines

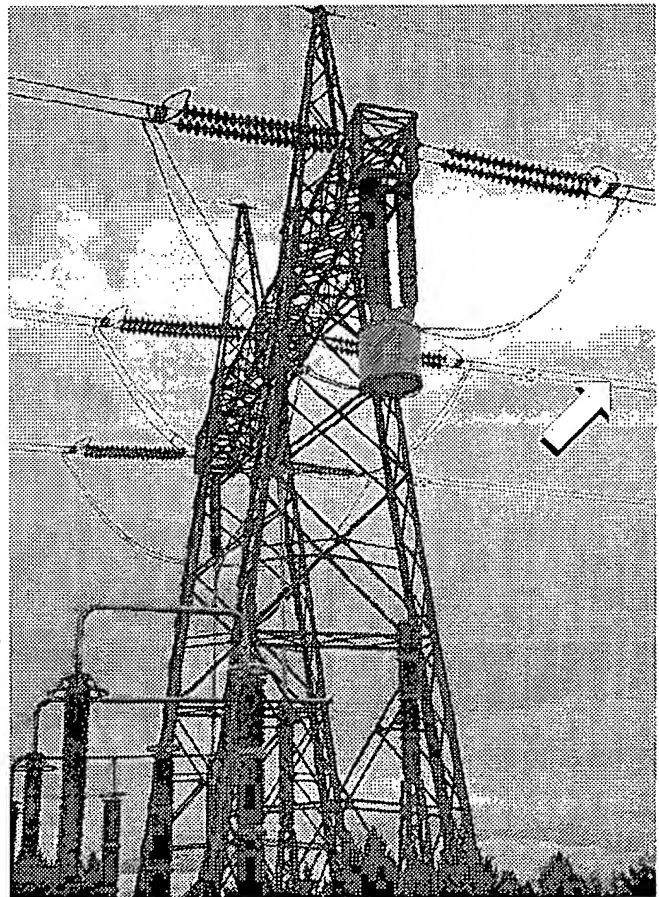
**Figure Caption:** [Public Service Company of NM] Electrical transmission towers and high-voltage (345,000-volt) power lines near Albuquerque, New Mexico. The arrow points to the energized wires, which are likely places for corona discharge to occur.

"The presence of moisture in the air or on the conductor promotes electrical conduction and reduces the voltage required for corona onset to occur," says Richard Johnson, an electrical engineer at the Public Service Company of New Mexico. There is always a small amount of corona discharge going on, he says. "The presence of moisture simply magnifies the effect."
